EVALUATION OF PERFORMANCE AND EARLY DEGRADATION OF A 180.8 KWP ROOFTOP ON A GRID-CONNECTED PHOTOVOLTAIC SYSTEM IN A COLOMBIAN TROPICAL REGION ENVIRONMENT

Cinthia, Audivet^a; Elena, Romero^b; Jesús, García^a; Ana, Fonseca^b; Horacio, Pinzón^a; Antonio, Bula^{b*}; Marco, Sanjuan^a

^aPROMIGAS S.A. E.S.P., Barranquilla, Colombia
^b Universidad del Norte, Barranquilla, Colombia
*email: abula@uinorte.edu.co

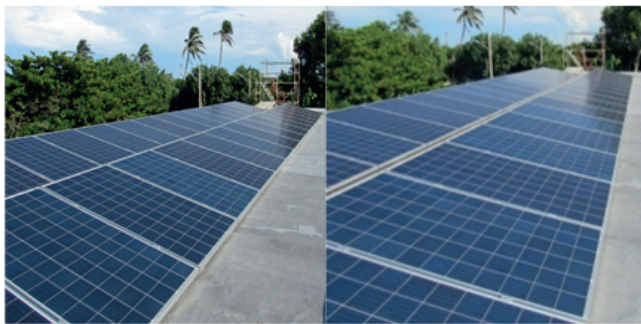
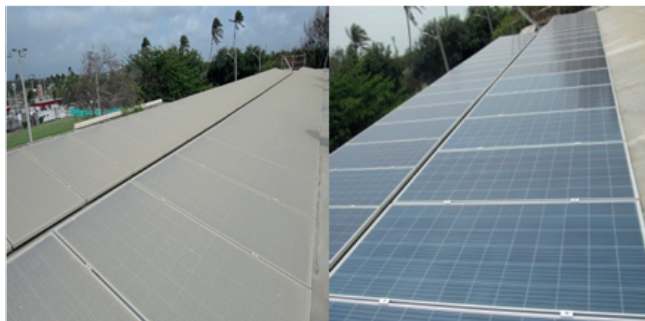
Figure 2 shows panoramic images of the same row of PV modules in the four inspection periods. Dust concentration is a direct function of dry (December – March) and rainy periods (April to November), an image corresponding to the end of dry periods (march before clean-up) shows high dust concentration. After the cleaning process there is a slight deterioration in the modules' color as compared to the first inspection. According to **Table 1**, the identified failure mode is discoloration.

Figure 2. Panoramic images of the same row of PV modules in the four inspection periods: a. October 2018, b. January 2019, c. March 2019 (before clean up), d. March 2019 (after clean up)

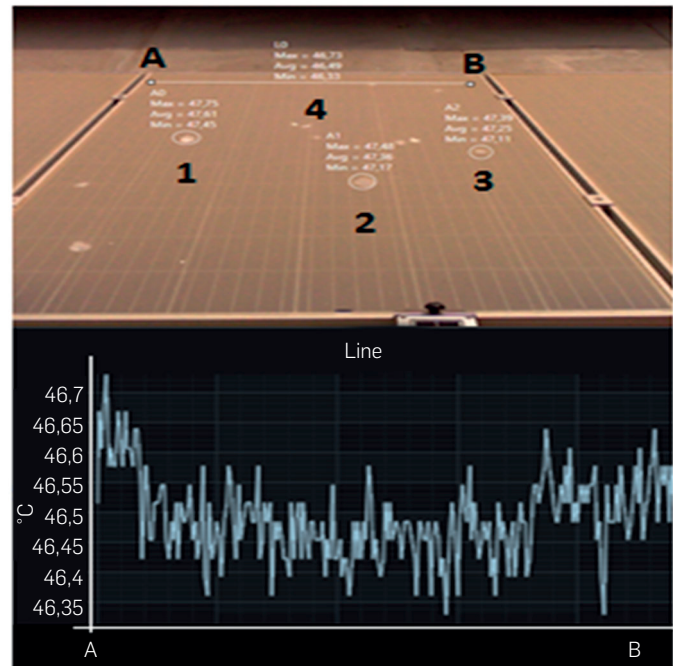
During the third inspection, a high level of dust content and a significant quantity of bird droppings were observed in the modules. A thermal analysis was performed to assess the module temperature performance; this analysis showed that the dust level maintains a homogeneous temperature on the surface, whose maximum value was 46.7 °C and minimum value was 46.35 °C, see **Figure 3**. Apparently, as the level of dirt increases, the modules temperature decreases; this phenomenon could be caused by the change in the amount of energy passing through the dirt layer.

Point	1	2	3	4
Max Temp. °C	47.75	47.48	47.39	47.73
Avg Temp. °C	47.61	47.36	47.25	46.49
Min Temp. °C	47.45	47.17	47.11	46.33

Figure 3. Thermal Analysis to assess module temperature performance

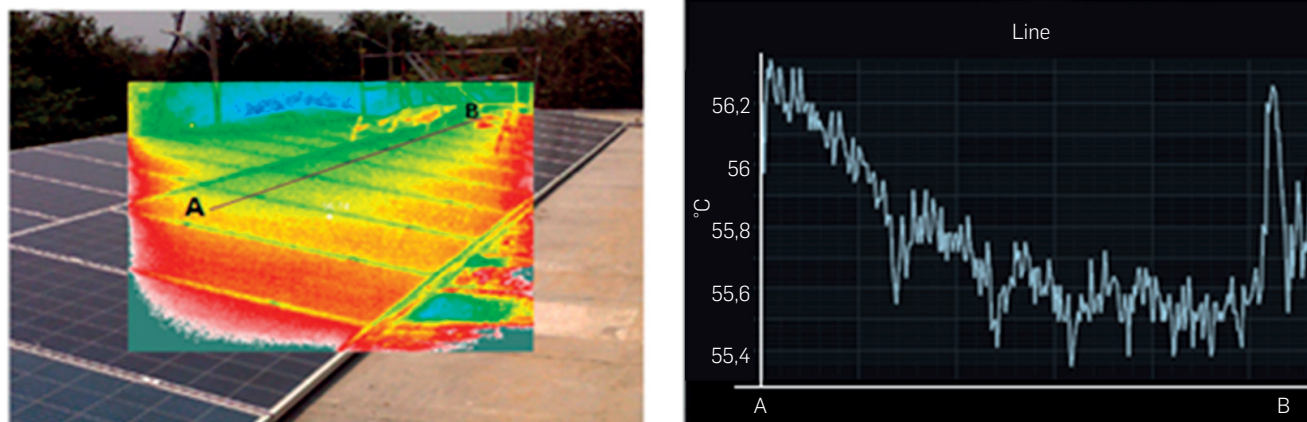
A thermal analysis was carried out after the cleaning process; such analysis showed that the modules temperature in the analyzed row varies by less than 1 °C. It was also noticed that discoloration has not generated changes in module temperature so far, see **Figure 4**.

Figure 4. Thermal Analysis after clean up to assess module temperature performance

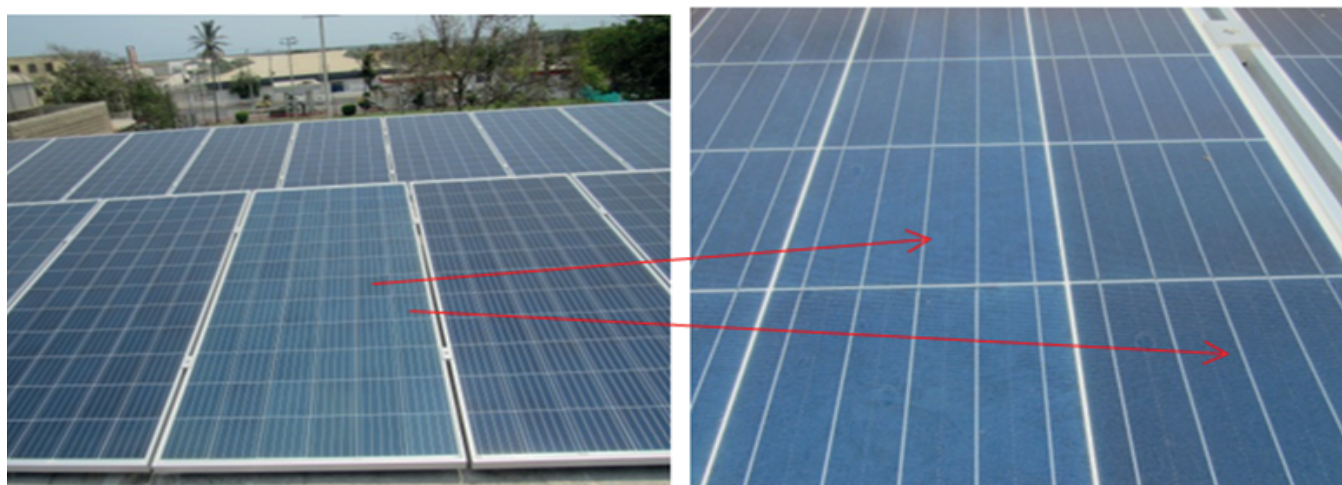
Figure 5 shows a discoloration between cells in the same PV module. A thermal analysis was carried out to assess the effect on module temperature; however, thermography indicated that the variation between these points did exceed 1 °C, see **Figure 6**.

Figure 5. Discoloration between cells in the same PV module

The early degradation analysis suggests discoloration as the most common failure mode. However, according to Figures 5 and 6, at this time, there is not a substantial contribution of this failure mode on module temperature. This phenomenon could cause a problem if there would be a loss of adhesion between the encapsulating polymeric and the cells of the module, causing penetration of water within it. There are no failure modes such as delamination, corrosion

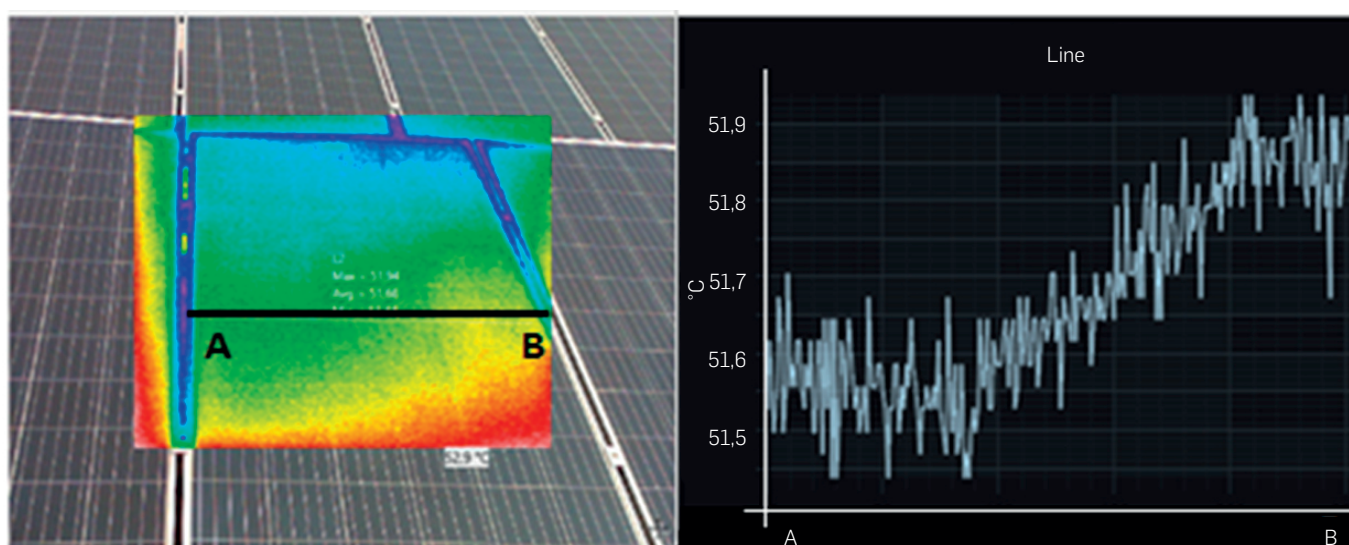
Figure 6. Thermographic analysis in cells which present discoloration

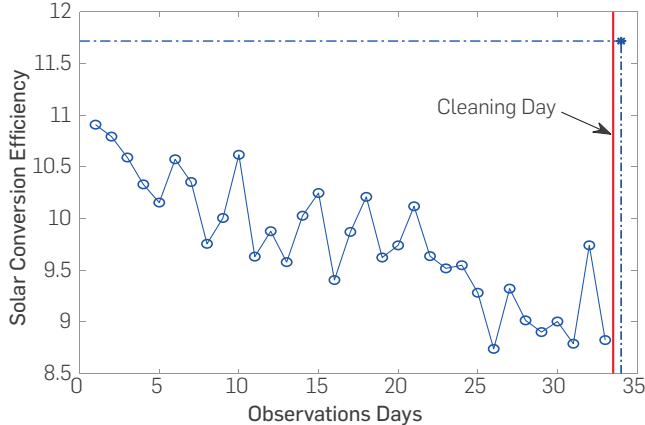
Figure 7 shows the solar conversion efficiency changes after 33 days of dust accumulation on the surface of the photovoltaic modules. Hence, there is a substantial reduction in system efficiency. Although the design efficiency value is 15.32 %, the highest value, measured on the first day of analysis, was 10.91 %, and the lowest value was registered on day 26, as 8.65 %.

Figure 7. Solar Conversion Efficiency performance.

On day 34, a cleaning process was performed on the photovoltaics system to analyze efficiency behavior; this value was registered with a superior performance of (11.72 %) and a global irradiance of 570 W/m^2 , which means an increase of 2.98 %. This value is marked with an asterisk in Figure 7.

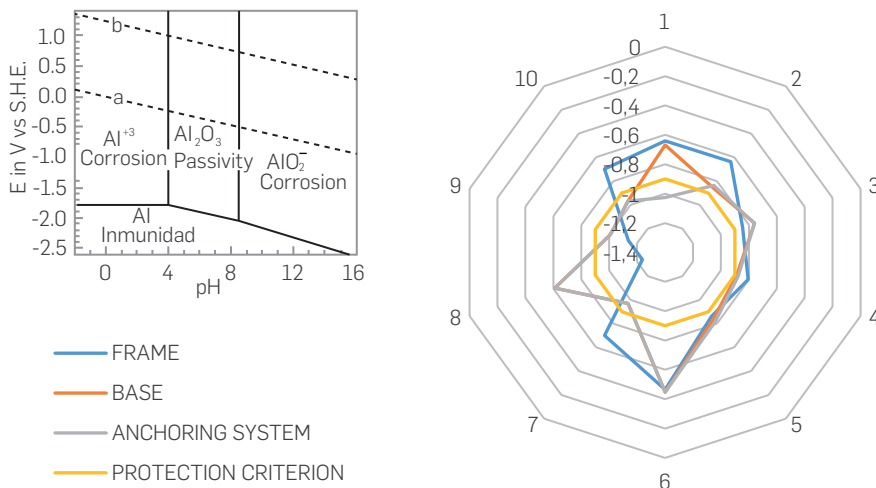
The galvanic series is the location of different types of materials with respect to their electrochemical potential. In the specific case of aluminum, potential measurements are obtained against a Cu/CuSO₄ electrode, allowing the identification of the tendency of corrosion, immunity or passivation of the material relative to the pH of the surrounding environment [22]. According to the cathodic protection criteria of the NACE RP 0169 standard, the aluminum metal structure is protected with more negative potentials of -0.9 volts [23]. **Figure 10** presents the potential measurements for the selected panels showing active corrosion processes, which is favored with the pH range between 4-8. This shows the formation of a protective layer of Al₂O₃. For the particular case of residues gathered in the selected points, the average pH measured was 7.06; therefore, the formation of passivating film is stable.

Figure 10. Photovoltaic panels corrosion potential (Based on [24])

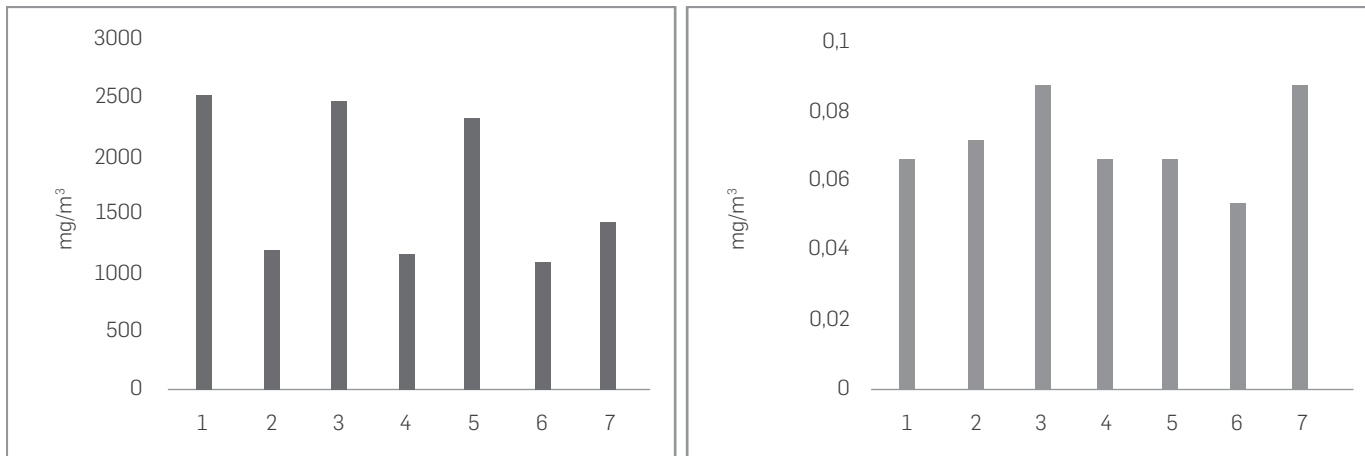
The atmospheric characterization is carried out in the presence of relative humidity greater than 70 %, which facilitates the condensation on metal surfaces, promoting the formation of a wet film that may contain contaminants such as chlorides and sulfides that accelerate the corrosion process [25]. **Figure 11** shows the reports of the concentration of chlorides and sulphides identified

Figure 11. (a) Chlorides concentration (mg/m^3); (b) Sulphides concentration (mg/m^3) material taken from the surface of photovoltaic panels
