EVALUATION OF PERFORMANCE AND EARLY DEGRADATION OF A 180.8 KWP ROOFTOP ON A GRID-CONNECTED PHOTOVOLTAIC SYSTEM IN A COLOMBIAN TROPICAL REGION ENVIRONMENT

Cinthia, Audivet^a; Elena, Romero^b; Jesús, García^a; Ana, Fonseca^b; Horacio, Pinzón^a; Antonio, Bula^{b*}; Marco, Sanjuan^a

^aPROMIGAS S.A. E.S.P., Barranquilla, Colombia
^b Universidad del Norte, Barranquilla, Colombia
*email: abula@uinorte.edu.co

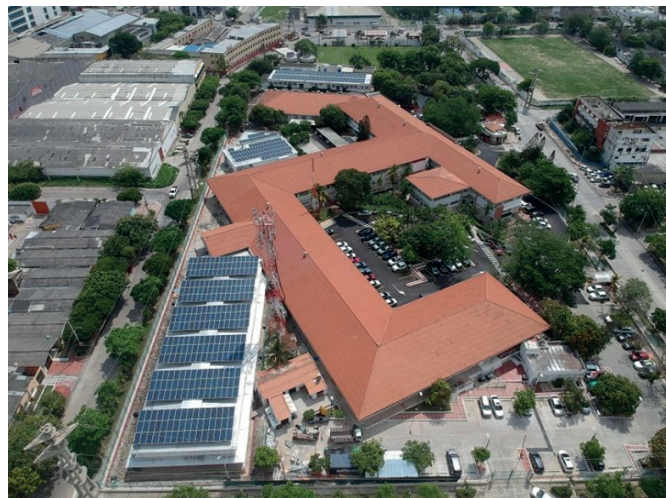
Figure 1 shows the system, which is divided in three subsystems located on three different rooftops, referred to as: Subsystem A, B and C. Each subsystem has its own inverter. The inverter corresponding to subsystem A is located in electrical substation 3, where the power generated by this subsystem is connected to the 460 Vac bar. The inverters of subsystems B and C are located in electrical substation 2, where the power generated by both subsystems is joined, and it is connected upstream of a reducing transformer of 480/214 Vac, to the bar of 214 Vac.

Figure 1. Aerial photography of solar PV system

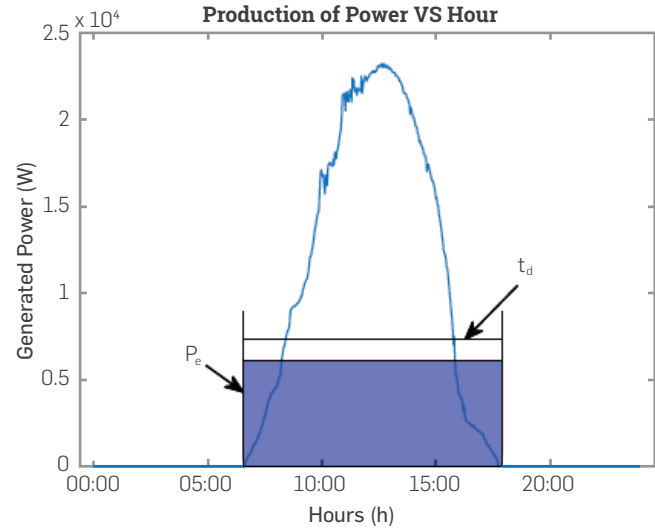
On the other hand, the energy generated per day during the study was in the range of 315.15 kWh to 644.1 kWh. These values were monitored using the SolarMan platform. In a normal day, the power production is not a constant value, but an equivalent power can be estimated knowing the value of the energy produced in one day, E_d , with time t_d , according to Figure 8.

Figure 8. Power production as a function of generated energy

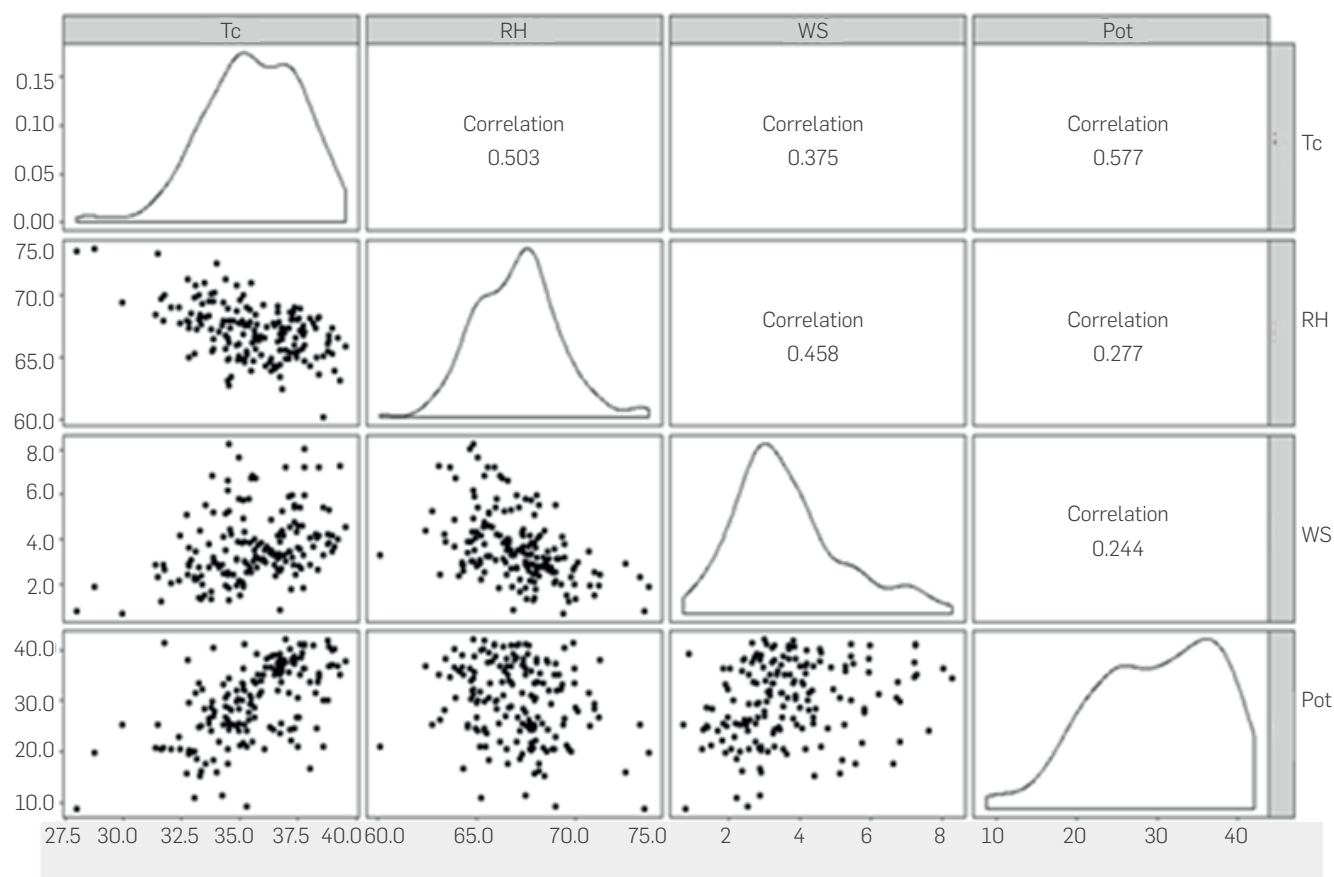
Figure 9. Correlation matrix for power, cell temperature, relative humidity and wind speed

The effect of the cell temperature, wind velocity, and relative humidity was also checked during the research. Six months of data were used to assess the effect of wind velocity, relative humidity, and cell temperature over panels energy production. The correlation analysis was conducted by such means **Figure 9** shows the correlation matrix, with the last column including the correlation between power generated and cell temperature, relative humidity, and wind velocity. Here, "Pot" stands for power, "Tc" for cell temperature, "RH" for relative humidity, and "WS" for wind speed.

Consequently, wind, relative humidity, and cell temperature were not considered in the final model.
